Type  
**Assessment Report**

Registration no  
**333DCJ**

VIN code  
**VR3F35GFRKY120370**

Type  
**Damage Report**

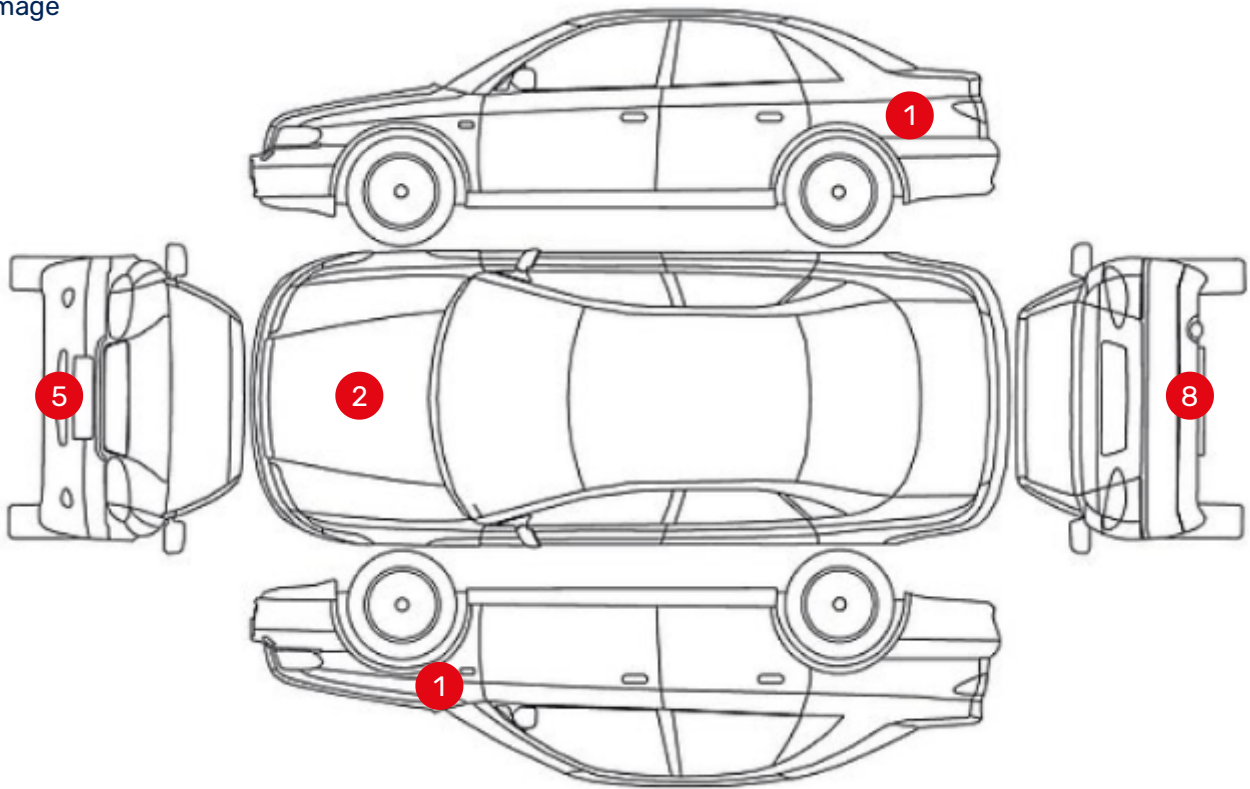
Type	Side	Body part	Image
Dent	Front	Front bumper	<a href="#">View image</a>
Paint damage	Front left	Mirror	<a href="#">View image</a>
Paint damage	Front	Hood	<a href="#">View image</a>
Paint damage	Front	Hood	<a href="#">View image</a>
Paint damage	Front	Front bumper	<a href="#">View image</a>
Paint damage	Front	Front bumper	<a href="#">View image</a>
Paint damage	Back	Rear bumper	<a href="#">View image</a>

Paint damage	Back	Rear bumper	<a href="#">View image</a>
Paint damage	Back	Rear bumper	<a href="#">View image</a>
Paint damage	Back	Rear bumper	<a href="#">View image</a>
Paint damage	Right	Body	<a href="#">View image</a>
Rust	Left	Fender	<a href="#">View image</a>
Scrape	Back	Rear bumper	<a href="#">View image</a>
Scrape	Back	Rear bumper	<a href="#">View image</a>
Scratch	Back	Rear bumper	<a href="#">View image</a>
Crack	Front	Front bumper	<a href="#">View image</a>
Other damage	Front	Front bumper	<a href="#">View image</a>
Other damage	Back	Rear bumper	<a href="#">View image</a>

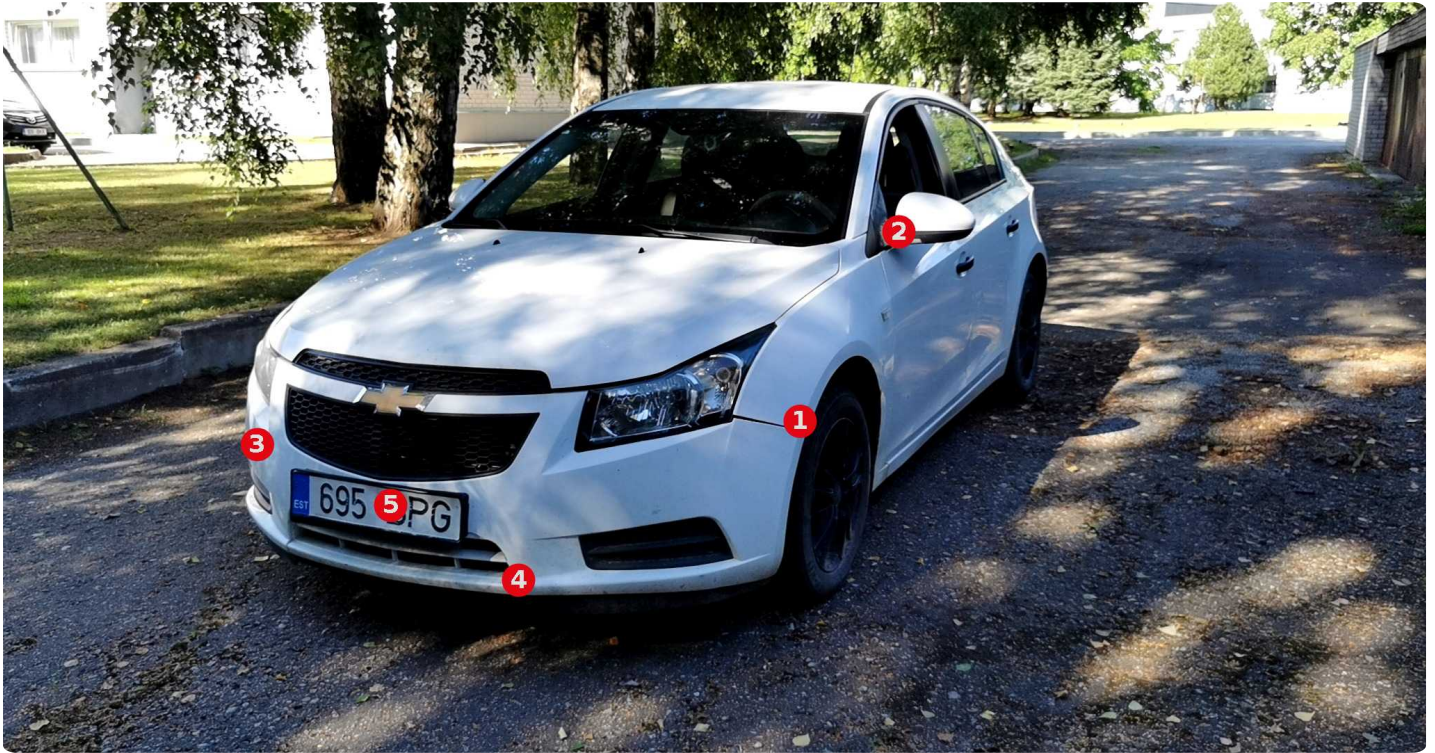
Image type  
**Front left**

Fender  
Rust

Mirror  
Paint damage

Front bumper  
Other damage

Front bumper  
Paint damage

Front bumper  
Dent

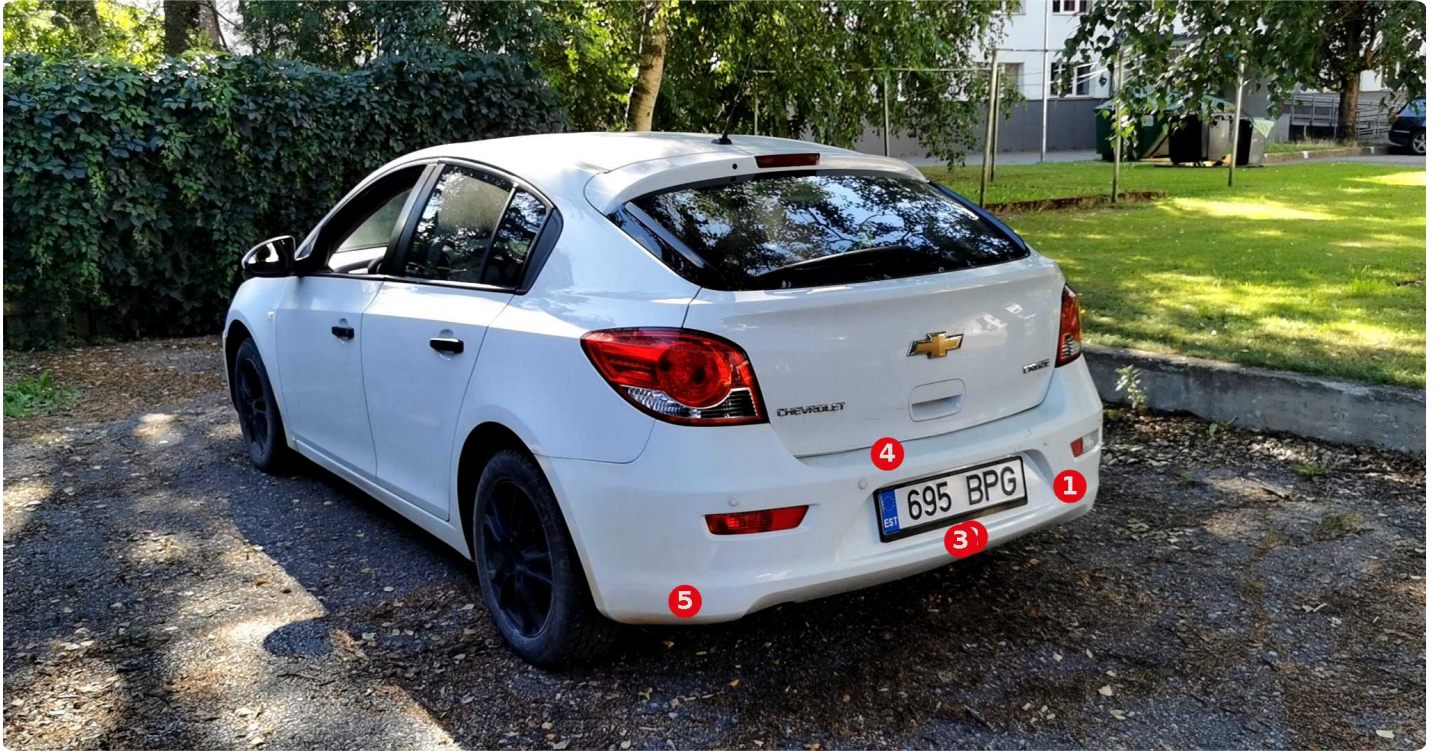
Image type  
**Back left**

Rear bumper  
Other damage

Rear bumper  
Paint damage

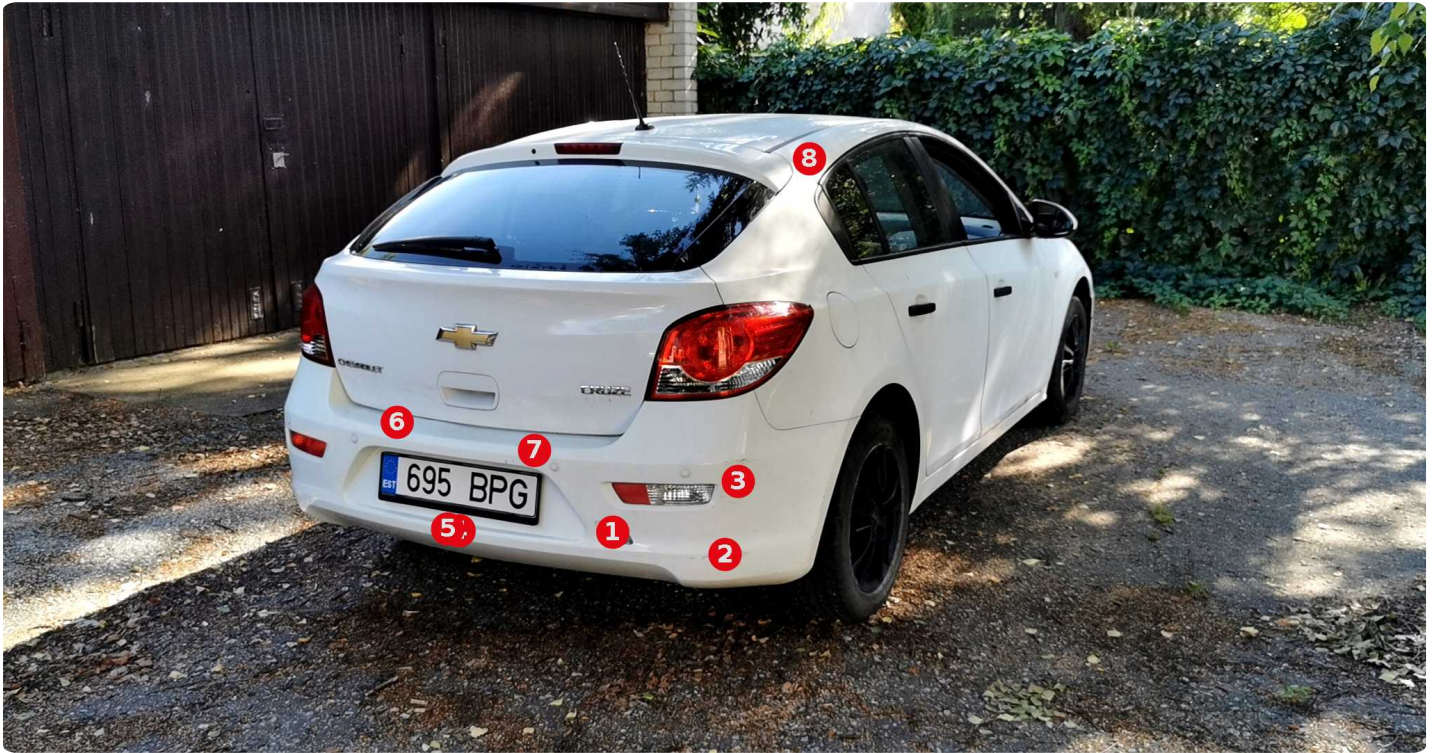
Image type  
**Back right**

Rear bumper  
Other damage

Rear bumper  
Scrape

Rear bumper  
Paint damage

Rear bumper  
Scratch

Body  
Paint damage

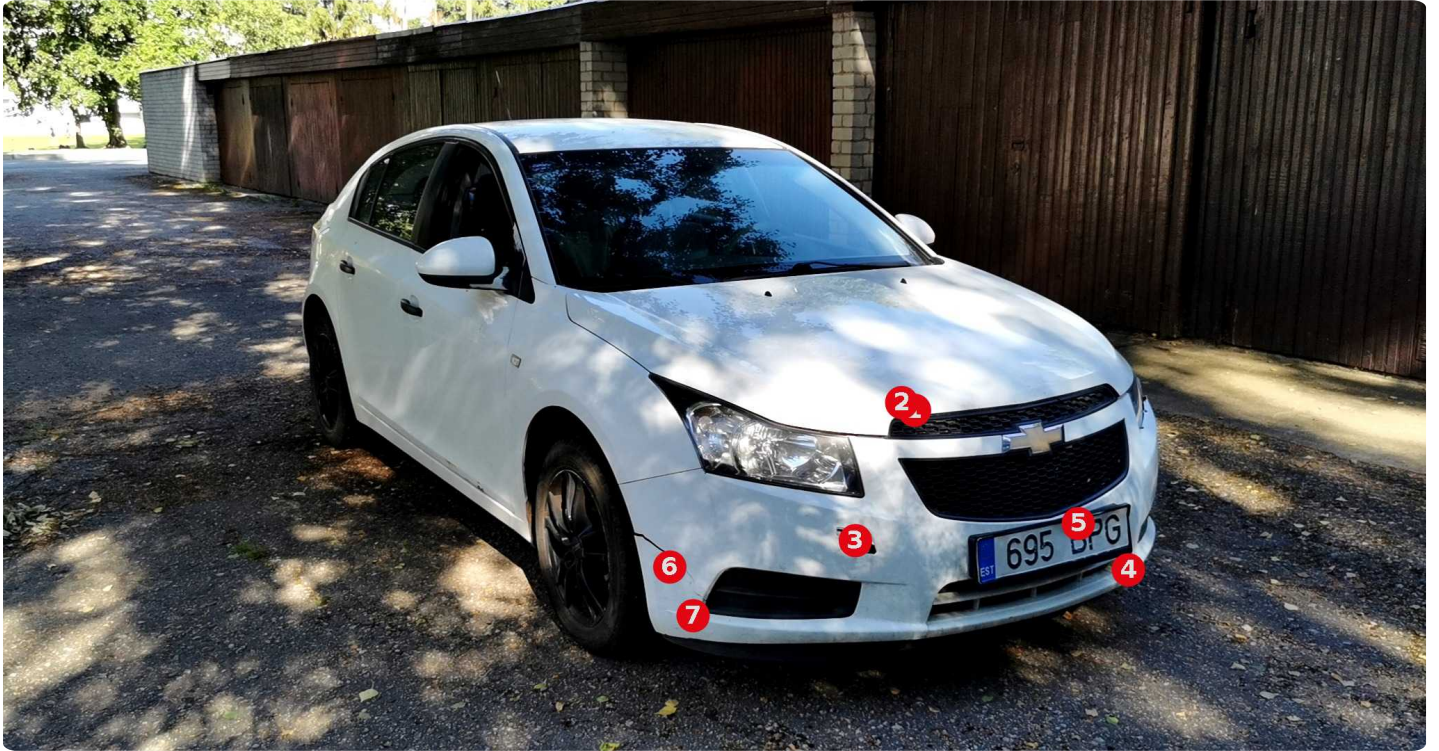
Image type  
**Front right**

Hood  
Paint damage

Front bumper  
Other damage

Front bumper  
Paint damage

Front bumper  
Dent

Front bumper  
Crack
